Manhole Inspection Summary

Manhole # S3500_049MH

Location Address: **206 23RD ST**

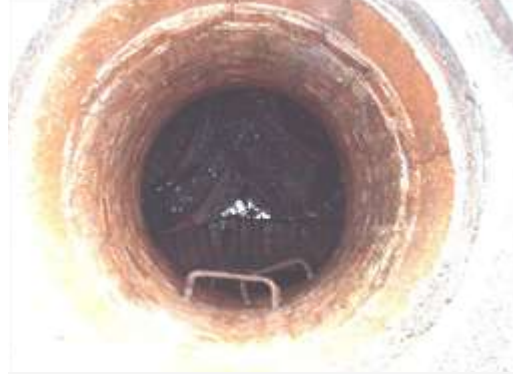
Top View

☒ **Debris** (not Condition related)

Count: **3** Missing: **0** ☒ **Corroded**

Corroded steps. Bench and Channel debris.

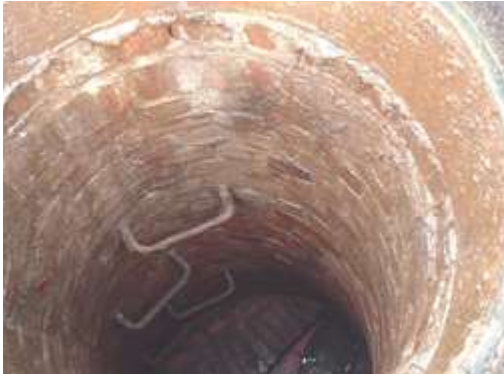
Defect

☒ **Leaks**

Condition: ☐ Sound ☐ Cracked ☐ Root Intrusion ☐ Loose Brick ☒ **Deteriorated**

Infiltration: ☐ None ☒ **Joint** ☐ Cracks ☐ Mortar ☐ Roots ☒ **Wall**

Infiltration: ☐ None ☐ Joint ☐ Cracks ☐ Mortar ☐ Roots ☒ **Wall**

Frame leaks. Adjustment deterioration and infiltration. Barrel infiltration.

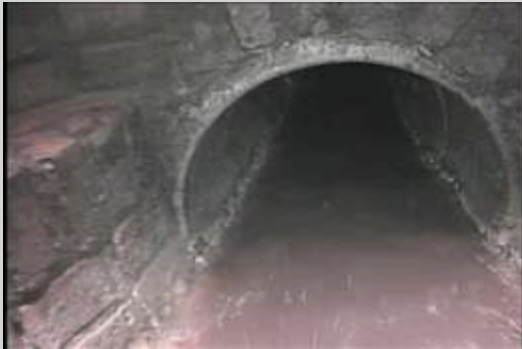
15 in. Circular Gravity Sewer Pipe Out @ 12 O'Clock

Deposits: ☐ None ☐ **Mud** ☐ Sludge ☐ **Debris** ☒ **Grease**

Infiltration: **None** Pipe Seal Cond: **Roots**

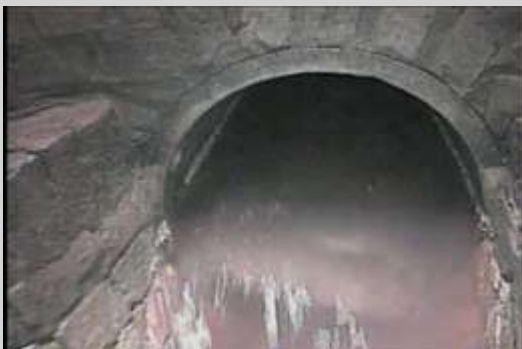
15 in. Circular Gravity Sewer Pipe In @ 3 O'Clock

Condition: ☐ Sound ☐ Cracked ☐ Root Intrusion ☒ **Deteriorated** ☐ Leaks ☐ Debris

Channel deterioration.

Deposits: ☐ None ☐ **Mud** ☐ Sludge ☐ **Debris** ☒ **Grease**

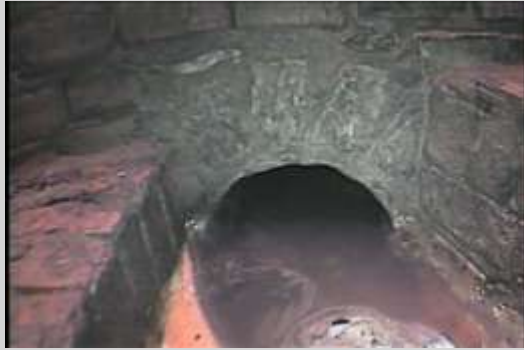
8 in. Circular Gravity Sewer

Deposits: ☐ None ☒ **Mud** ☐ Sludge ☒ **Debris** ☐ Grease

Silt Depth: **2** (in.)

Deposits Extent: **Medium**
